TEST REPORT

Report No.: B2739.02-501-47

TREMCO[®], INCORPORATED
Beachwood, Ohio

PRODUCT TYPE: Air Barrier System

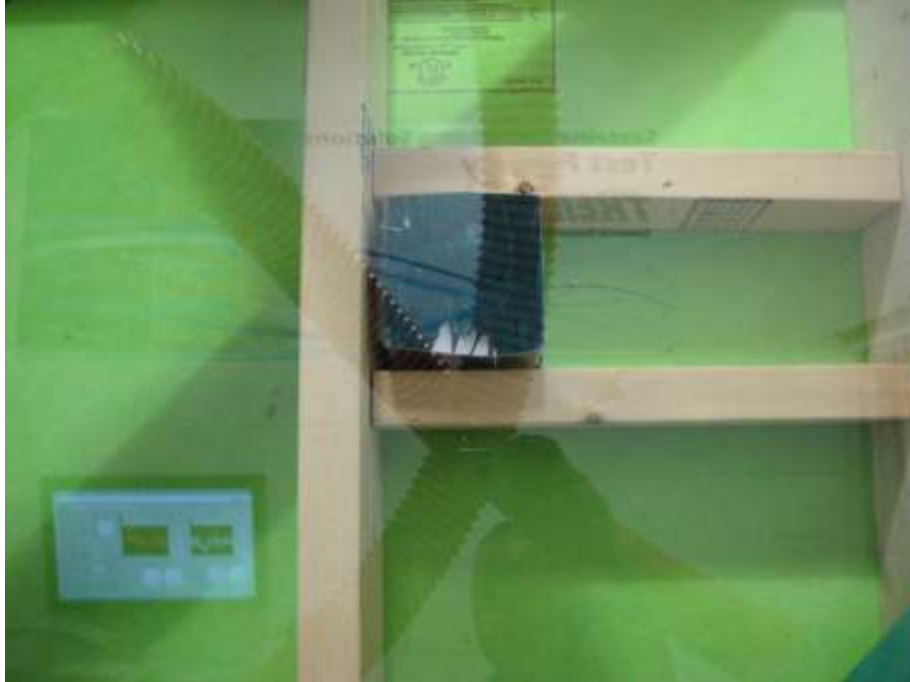
Title of Test	Results	Allowed
Water Penetration, per ASTM E 331 at 300 Pa (6.24 psf)	See Notes (Two hour duration)	No Leakage
<p>Observations:</p> <ol style="list-style-type: none"> 1. After approximately 61 minutes, water penetrated internal to the duct. No leakage occurring from the perimeter of the penetration. 2. After approximately 108 minutes, some water dripping from the interior of the duct. All dripping is relative to leaks internal to the duct. No leakage occurring from the perimeter of the penetration. 3. Testing was terminated after 120 minutes of water spray with a 6.24 psf pressure difference.

Photo No. 5
Interior view of water penetration internal of duct dripping out
